# THE PREVENTION OF MECHANICAL INJURY DURING TRANSIT OF NEW-CROP POTATOES<sup>1</sup>

W. R. BARGER,<sup>2</sup> E. V. SHEAR,<sup>3</sup> AND L. L. MORRIS<sup>4</sup>

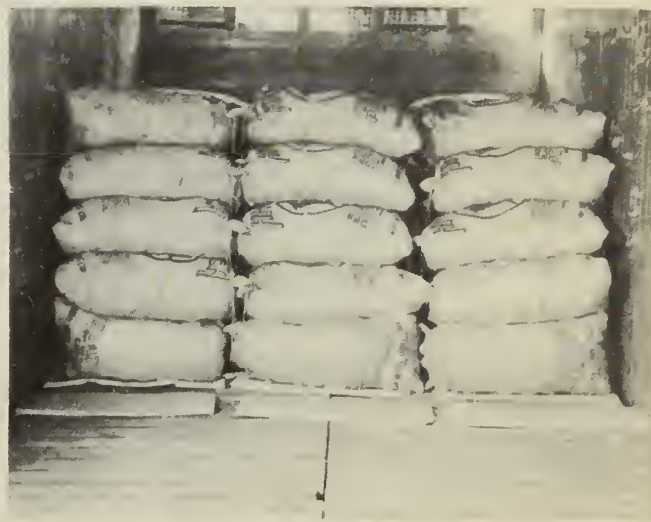
Fig. 1.--Arrangement of a 36,000-pound 3×5 load. There are 11 stacks in each end of the car, plus 30 bags in the doorway. Note that the bottom bags rest on their edges and are therefore subject to rocking in transit.

Transit injury was studied in two types of loads, each containing 360 bags. In the 3×5 load, there were 11 stacks in each end of the car, 3 rows wide and 5 layers high, with all bags laid crosswise of the car (fig. 1). The doorway provided space for 30 bags, set in 2

crosswise rows. During loading, the potatoes were moved into the cars in piles of 5 bags on a hand truck. Each pile was placed in the car (without rehandling) by tipping or bumping it forward from the truck. The bottom bag was set on edge on the truck so that the pile could be tipped forward more easily during the loading operation; it remained in this position in the car. These bags on edge tended to roll or rock in transit which action could result in considerable abrasion of the potatoes next to the floor rack.

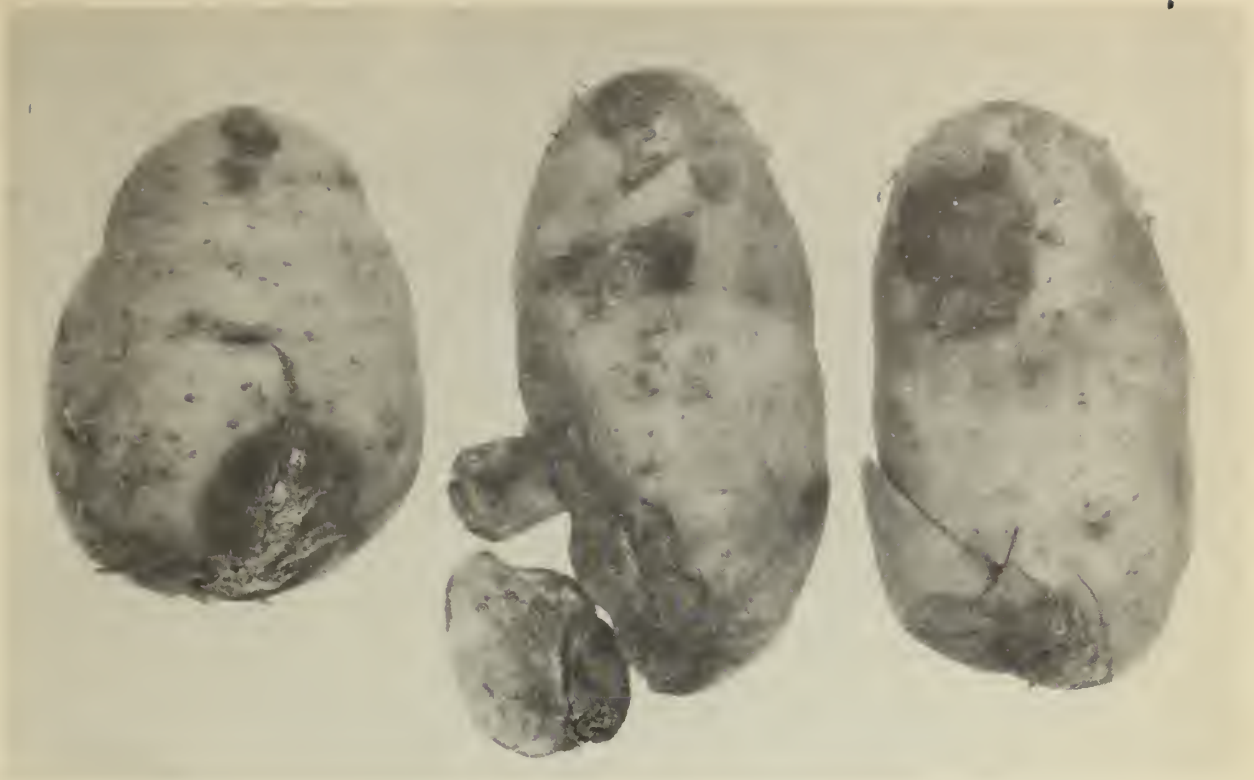
Fig. 3.--Types of transit damage classed as deep injury in this report. These were from bottom-layer bag that was not protected by floor pads.

contents of several bags were scored. Cutting the bag so that the tubers were examined in about the same position that they occupied during transit gave an accurate picture of the occurrence of floor bruising. Deep injury included crushing, severe bruising and cracking (fig. 3), and other forms of deep mechanical injury. Nearly half the potatoes arriving with deep injury were unsalable. Shallow injury included bag marks or imprints of the bag material, slight bruises, and browned or discolored spots resulting from pressure or from rubbing against other potatoes in transit (fig. 4). Potatoes with shallow injuries were salable but, obviously, had lost some of their market quality. The browned spots here reported do not include the defect known as surface browning or wind injury. Browned spots caused by bruising occur on all parts of the tuber; they show evidence of pressure or rubbing, whereas surface browning after wind injury is found only on previously skinned areas. The decay encountered was mostly soft rot. Occasionally it was in an incipient stage, causing only slimy pits in the skin; but usually it was advanced, spreading slime and ooze to adjacent tubers.

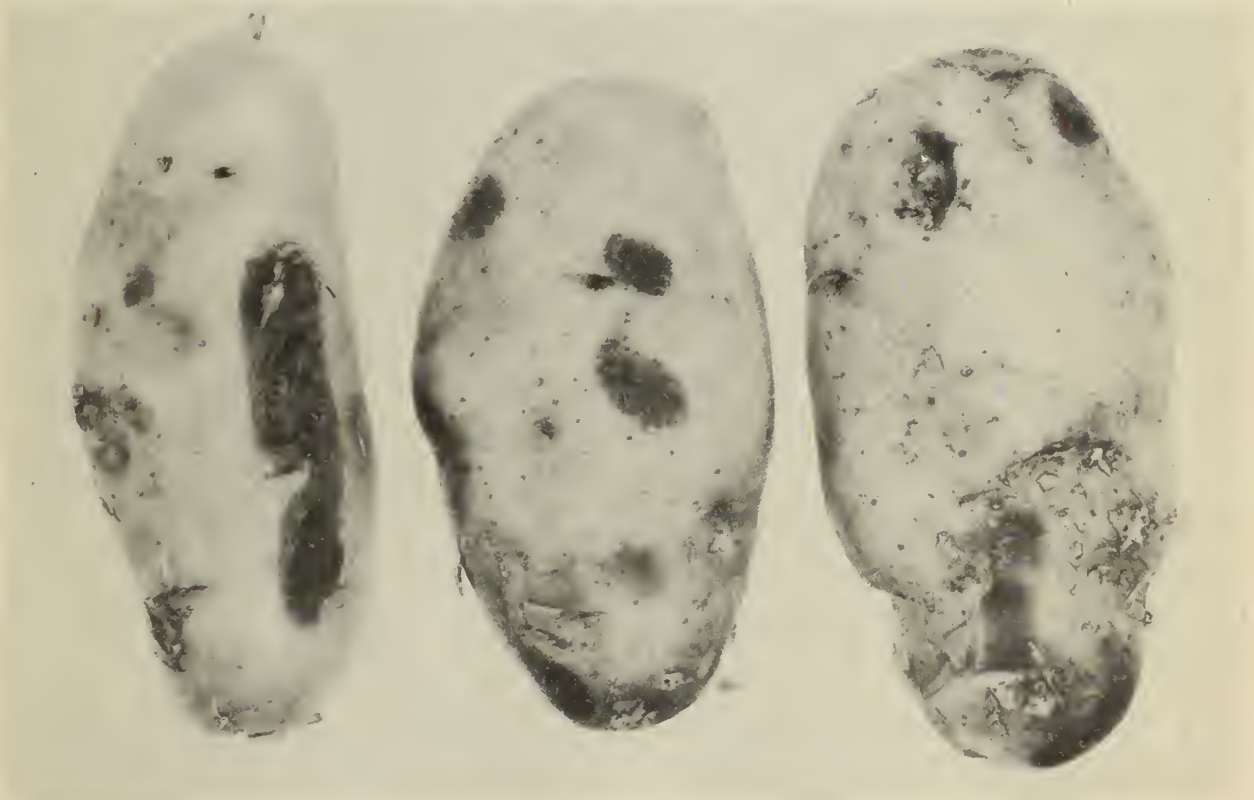
Fig. 4.--Types of transit damage classed as shallow injury in this report.
